# INVESTIGATION OF SLUMPING FAILURE IN AN EARTH DAM ABUTMENT AT KOTZEBUE, ALASKA

Charles M. Collins and Terry T. McFadden

July 1977

Prepared for  
U.S. PUBLIC HEALTH SERVICE  
By  
CORPS OF ENGINEERS, U.S. ARMY  
COLD REGIONS RESEARCH AND ENGINEERING LABORATORY  
HANOVER, NEW HAMPSHIRE

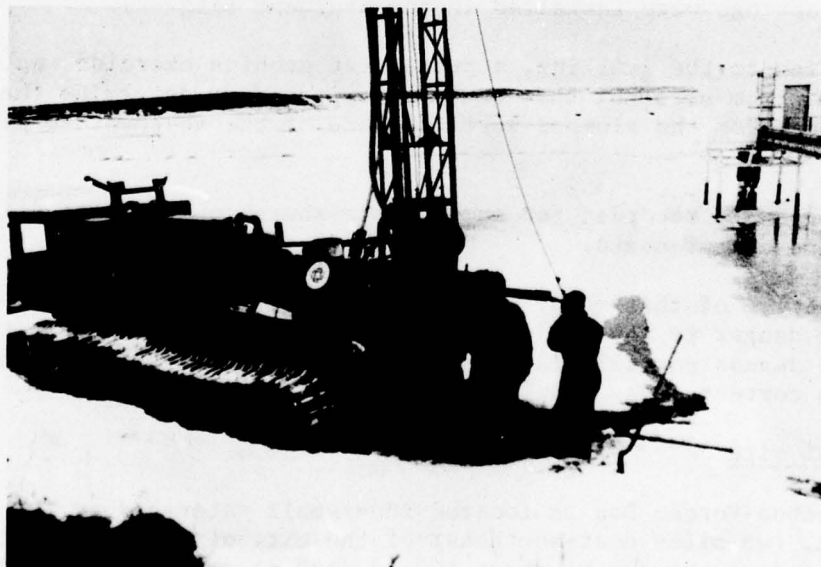
*Figure 1. Drill rig on the ice behind the dam.*

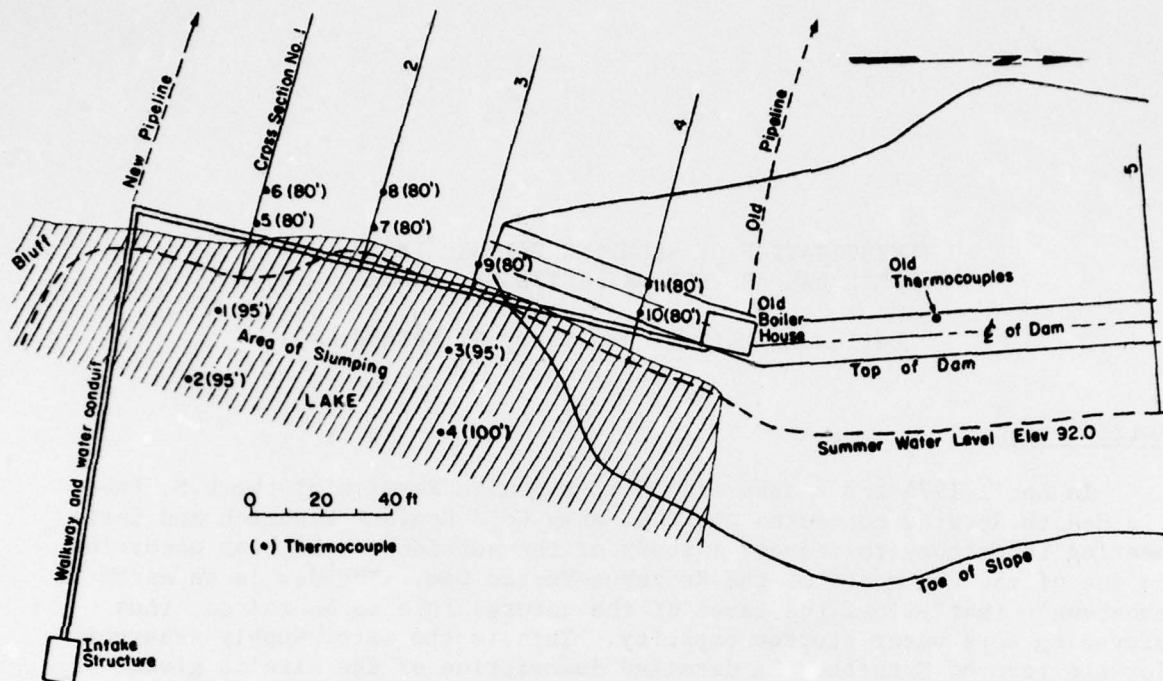
Figure 2: Location of drill holes with thermocouple assemblies and cross sections, Vortac Dam, Kotzebue, Alaska.

Slumping and collapse are occurring along the steep bank facing the water from approximately the boiler plant to the southern end of the dam where it joins the bluffs (Fig. 2). Slumping from these bluffs is also visible along the southwest side of the lake (Fig. 5).

In April 1976, Jim Thrasher and Associates, under contract with CRREL, drilled four holes through the ice on the upstream face of the dam and abutment face near the south end (Fig. 2, holes 1-4). The drill logs of these holes are shown in Figures A1-A4 (App. A). Thermocouple assemblies were installed in each hole with thermocouples at 47, 63, 79, 87 and 95 ft below the reservoir bottom. The purpose of the drilling was to determine the location of any thaw bulb that might exist under the lake and to determine if the thaw bulb extended below or into the dam. The enlargement of this thaw bulb due to reservoir filling could account for the slumping at the southern abutment.

In August 1976, Jim Thrasher and Associates drilled seven 80-ft holes (Fig. 6) on the dam crest adjacent to and through the southern abutment (Fig. 2, holes 5-11). Thermocouple assemblies were installed with thermocouples at 10-ft (3-m) intervals to a depth of 80 ft (24 m).

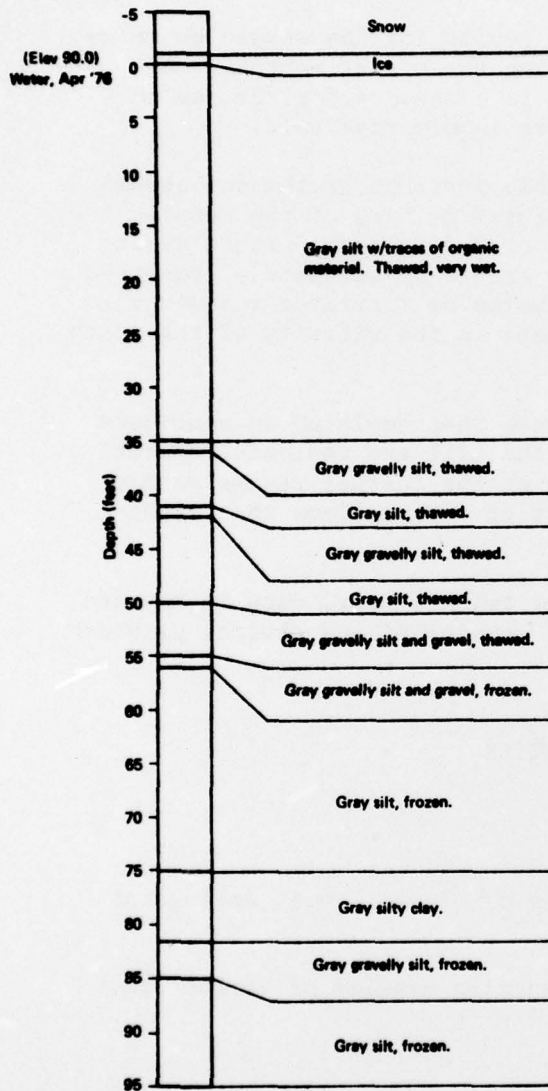
Figure A1. Drill log for hole no. 1.

None of the thermocouples in the holes indicated a thawed condition; that is, the thaw bulb below the lake did not extend as deep as the top-most thermocouple on any of the strings.

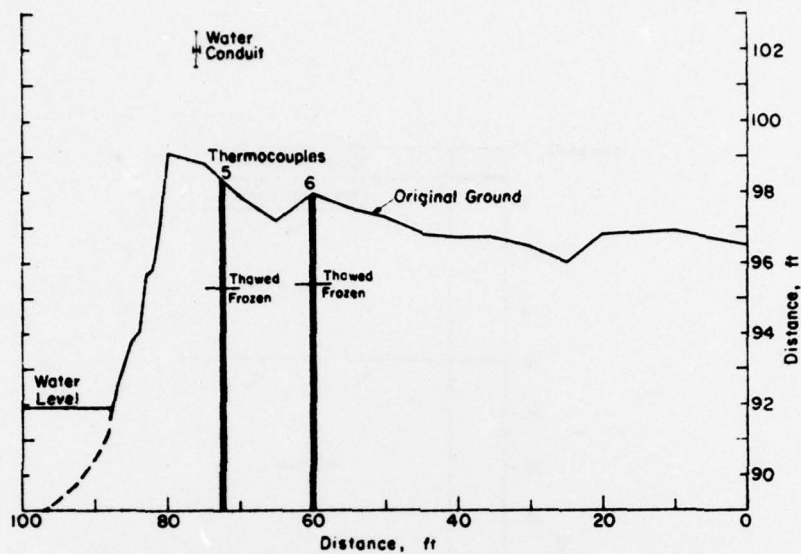
Figure B1. Cross section no. 1.

Five cross sections were made across the dam (see Fig. 2 for locations). Figures B1-B5 (App. B) show these cross sections. The cross section shown in Figure B2 gives the location of permafrost probings which were made in the near vertical upstream bank of the dam abutment and shows the zone of thawed material.
